Northchurch, Berko, – Location Report

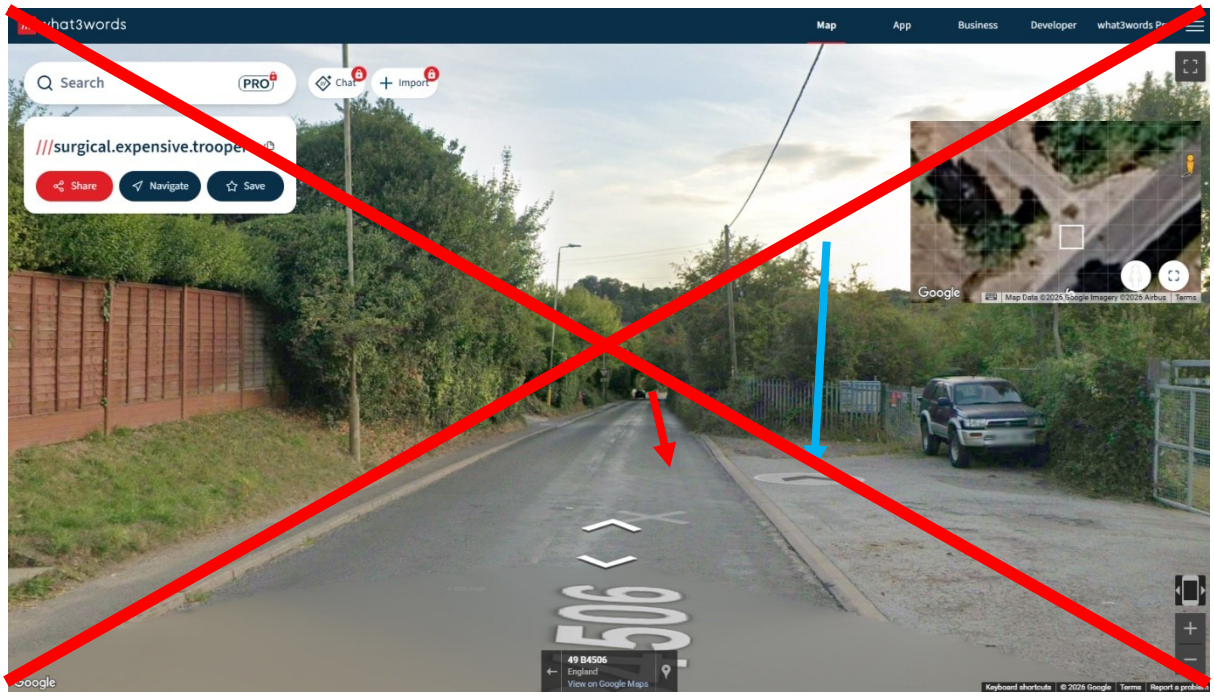
What3words /// surgical.expensive.trooper

New Road **Rejected**

The entrance to Northchurch upper allotments and Sunnyside Rural Trust – Location visibility insufficient to allow SID sign to detect approaching vehicles travelling northeast along New Road. This is due to heave vegetation along the edge of the roadway with no footpath. The entrance to the allotments is not suitable for the volunteers or equipment to be housed safely and will cause an obstruction to road users view of adjoining and leaving the allotments.

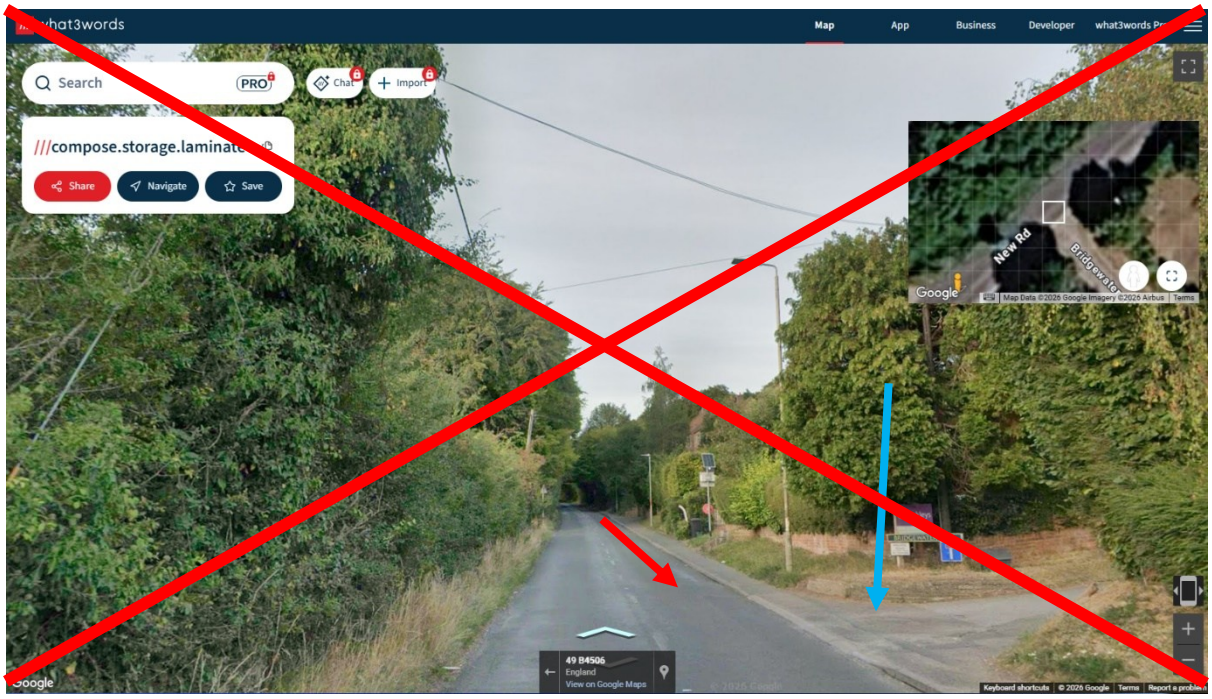
What3words /// compose.storage.laminate

New Road Rejected

The junction of Bridgewater Hill – Location visibility sufficient to allow SID sign to detect approaching vehicles travelling southwest down New Road. However, there is a fixed SID sign approximately 50yrds away from the location and could cause conflicting readings between the two SIDs. This location is also within the 161 mts away from the 40mph zone and will pick up vehicles outside of the 30mph zone. This location will also not allow road users an unobstructed view of adjoining New Road from Bridgewater Hill. The footway is not sufficiently wide enough to provide a minimum of 1.0 mtr clear and unobstructed footway width.
